## INJECTION MOLDING PROCESS USER GUIDE

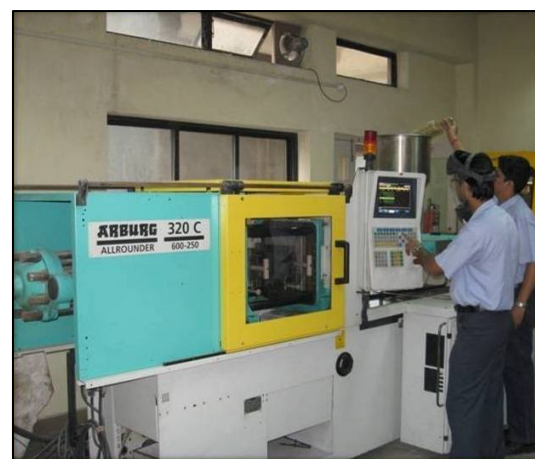
### NOZZLE

The nozzle is in contact with the sprue-bushing for a high percentage of the total cycle time during normal operations, with the sprue-bushing having a considerably lower temperature than the melt and nozzle. Gharda G-PAEK polymers have a sharp crystallization point i.e. 335°C and will solidify quickly if the melt temperature falls below crystallization point Therefore, it is important to ensure that an adequately large heater covering the majority of the nozzle is fitted to prevent solidify off. Extended nozzles are not generally recommended for use with Gharda G-PAEK polymers because of the increased risk of solidification and / or degradation in the nozzle. At the recommended process temperatures, the viscosity of Gharda G-PAEK polymers is generally high enough to allow an open nozzle system. Shut-off nozzles are not recommended because they frequently contain melt dead spots and restrict injection pressure.
